# Dynamic characteristics and model updating of damaged slab from ambient vibration measurements

Huzaiifa Hashim, Zainah Ibrahim, Hashim Abdul Razak

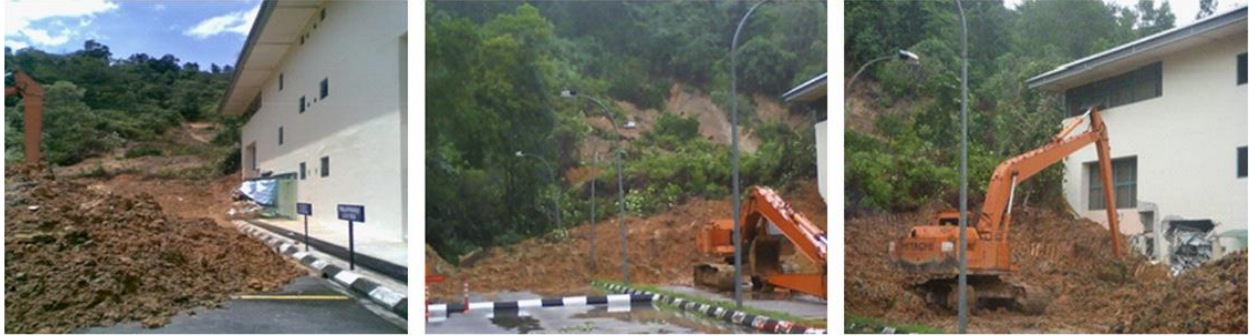
Fig. 1. Landslide area and clearing works in progress.

The structure considered in this investigation comprised of a three storey reinforced concrete frame building which housed the administrative offices and library of one of the faculties in the main campus of University of Malaya. The building was built in 1999 and located at the toe of a hill. Due to abnormal heavy rainfall in October 2008, a slip failure of the soil on the slope occurred triggering a landslide and burying some parts of the ground and first floor at the rear of the building. [Fig. 1](#) shows the landslide area while clearing works was in progress. The impact on the structural frame resulting from the movement of soil during the landslide caused severe damage on the perimeter beams. In addition the massive amount of soil into the building resulted in excessive loading on the first floor causing some parts of the floor slab to crack. However, the main columns, beams and slab of the second floor remain unaffected and intact. The total amount of soil removed from the site during the clearing work amounted to about 16,000 m<sup>3</sup>. Consequently the building was vacated and rendered unsafe to occupy until full structural investigation was carried out and repair work on the building completed. [Fig. 2](#) illustrates the condition of the perimeter
