Mangrove Restoration Activities on a Degrading Coastal Strip in Sg Hj. Dorani, Selangor, Malaysia

**Rozainah, M.Z., Noraini M.T., Roslan H., Yu Yin, Oswin, S.D.
and Babak, K.**

(Paper presented at the **19th International Conference of the Society for Ecological Restoration** held on 23-27 August 2009 in Perth, Australia)

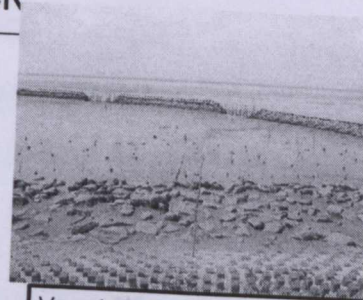
Vegetated coir log on site

Vegetated coir log in nursery

- Between L-Block and land, installation of bamboos, fascines, coir logs and geo piles took place.
- Mangrove seedlings were grown in coir logs in nursery for 5 months (since July 08) before transplanted on the coast.
- Reading on growth only conducted from Sept 08 (in nursery) and continued on site.
