Weatherability of coated fabrics as roofing material in tropical environment

H. Abdul Razak, C.S. Chua, H. Toyoda

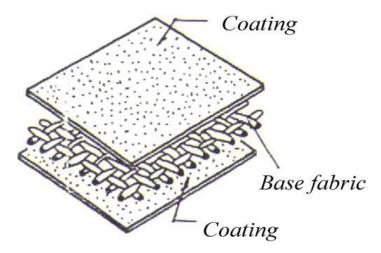
Fig. 1. General structure of coated fabric.

These structures which are referred to as membrane or tension structures utilises coated fabrics which are composites comprising of synthetic \$bres as the base and a compatible coating, as illustrated in Fig. 1. Among the numerous compatible

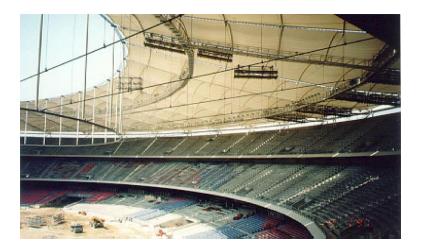
Fig. 2. Commonwealth sports stadium, Bukit Jalil, Malaysia.

Membrane roofs have become increasingly popular in Malaysia during the last few years, the most recent and major project being the construction of the sports stadium for the Commonwealth Games in 1998 as shown in Fig. 2. Malaysia has a hot and humid climate being situated about 2 N of the Equator. Day temperatures normally rise above 30 °C, while during the nights they rarely drop below 23 °C. Solar radiation which is closely related to the sunshine duration is seasonal and spatial variations occur very much the same as in the case of sunshine, which on average is about 6 h=day. The climate is dominated by the e7ect of two monsoons or "rainy seasons", which a7ect di7erent parts of Malaysia to varying degrees giving very large variations in monthly average rainfall throughout the country. Thus with much harsher weather conditions, it is expected that the weatherability of the fabrics will be put to much greater trials. Moreover, the results obtained from exposure test conducted in Malaysia would supplement existing data and information from previous exposure tests. Thus the main objective of this study is to establish the performance characteristics of various coated fabrics exposed to typical tropical weathering conditions. The performance characteristics are related to changes in appearance and functional aspects of the exposed surfaces, which includes dirt repellency, discolouration and coating condition, and the results obtained during the \$rst two years of exposure are presented in this paper.

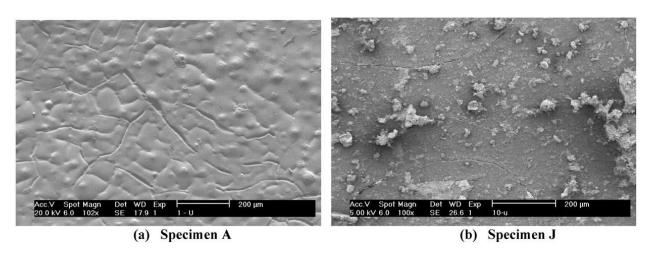
Fig. 7. Dirt repellency of fabrics, (a) specimen A, (b) specimen J.

The micrographs shown in Fig. 7 highlight the selfcleaning properties of both PTFE-coated (specimen A) and PVC-coated (specimen J) fabrics. Both the specimens are not surface treated but it is evident that there is visually no signs of dirt or adherence of large particulates on specimen A, while on specimen J the presence of airborne particulates is rather extensive.

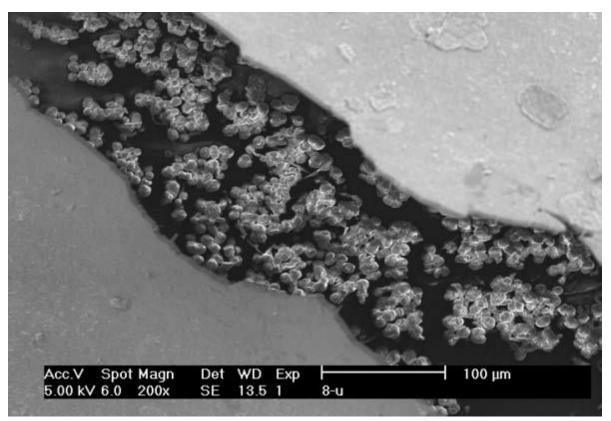
Fig. 9. Fungal growth in crack.

The e7ect of di7erent thickness of \$Im on the stability of the materials can be observed in Fig. 8. Specimen G with a thicker layer of PVDF film is less susceptible to cracking as compared to specimen H which was cracked and had peeled o7. Furthermore, the occurrence of wide cracks on specimen H promoted the growth of fungus as shown in

Fig. 9. This contributed to the exceptionally high colour di7erence and particulate density values as given in Fig. 5.
