Mohd. Zamin, Bin Jumaat, [Kabir, Md Humayun](#), & Obaydullah, M (2010) Structural performance of reinforced concrete beams repairing from spalling. *European Journal of Scientific Research*, 45(1), pp. 89-102.

## **Structural Performance of Reinforced Concrete Beams Repairing from Spalling**

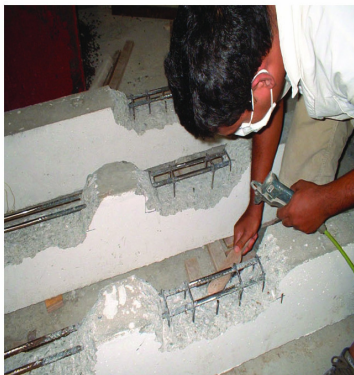
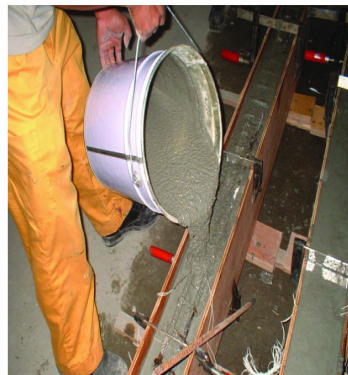
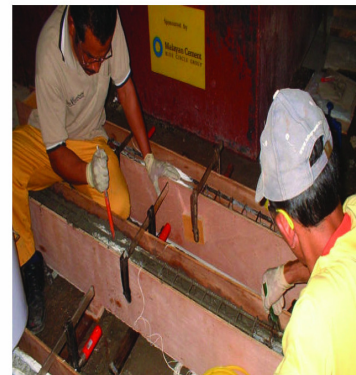
Loose and unsound concrete in the various spalling zones along the length of the reinforcement beam were cut away by means of a steel chisel. The resulting grit and dust were removed by means of a wire brush, air blower and water jet as shown in Plate 1(a).

**Plate 1:** a) Surface Preparation b) Application of Sika Microcrete 2000 to Beam Surface and c) Sika MonoTop R40 on wet surface

Wooden formworks were used in both repair works to give the repaired areas their desired shape. A few hours prior to the repair work, the substrate was properly saturated by filling the formwork with clean water. The water was then drained just prior to the commencement of the repair work and the formwork was made leak proof by the free-flowing nature of the Sika Microcrete 2000 material. The Sika Microcrete 2000 was mixed with clean water to a trowelable consistency as recommended by the manufacturers. Sika MonoTop 610 was then applied on the surface of steel and parent concrete as a bonding bridge before the repair material was applied. Three layers of micro-concrete, each of maximum thickness 25 mm were applied by pouring, in the method shown in Plate 1(b). Proper compaction was carried out to remove air voids by hammering and shaking sticks in each layer.

The prepared substrate was soaked thoroughly with clean water until it was uniformly saturated and no surface water was present. The steel reinforcements were made rust free and primed with two coats of Sika MonoTop 610. This material was then applied on the surface as a bonding bridge before the repair material was applied. The Sika MonoTop R40 (PMCM) was mixed to a trowelable consistency with the addition of clean water and “wet-on-wet” work was then performed on the bonding bridge as shown in Plate 1(c). Since the thickness limitation of each application layer was 35 to 40 mm, two such layers of MonoTop R40 were applied in order to get the required 75 mm thickness. Proper compaction was carried out at each layer to remove air voids.

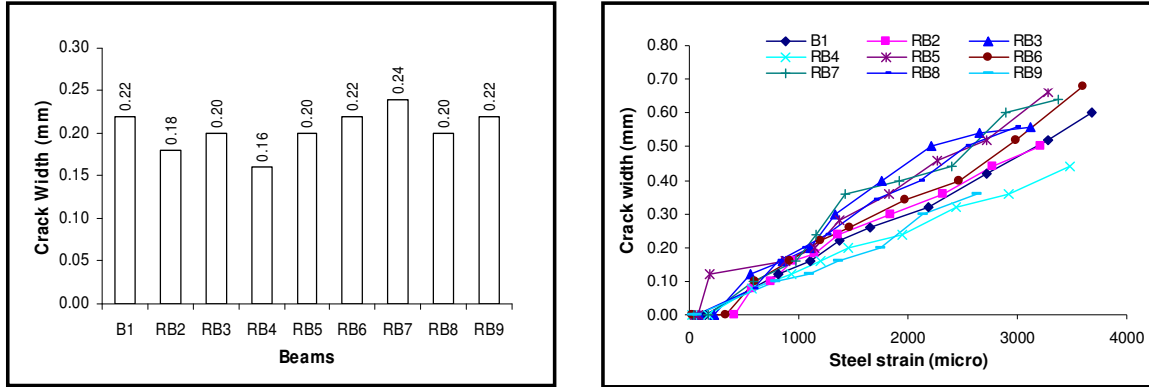
Fig. 6(a) shows the maximum crack width for all beams at service load and. Compared to the control beam, the beams repaired with FFSCM, namely beams RB2 and RB4, show smaller width of cracks. It can also be seen that the repaired beams RB3, RB5, RB7 and RB8 have the crack width differs by a small extent than that of the control beam, while the crack width of beam RB6 and RB9 are similar to that of the control beam. This small variation in crack width can probably be attributed to the variations in the number of cracks, the position of repair zone, the tensile strain of the steel bars, the thickness of the cover, the bond characteristics of the reinforcement, the distribution of the reinforcements, the diameter of the steel bar used, the distribution of the strain from the steel to the concrete surface, the bonding of the repair materials with steel and concrete and the erroneous reading of crack widths.

Figure 6(b) shows that the crack widths for all beams increase linearly with increasing steel strain, which is in agreement with the assumptions reported by Broms [21]. He mentioned that the average crack width increased linearly with increasing thickness of concrete cover and with increasing steel strain. Beams RB4 and RB9 shows less strain compared with the other beams.

**Figure 6:** a) Maximum Crack Widths at Service (25 kN) Load and b) Crack Width-Steel Strain Relationship

The ACI code specifies that at service load, the limiting crack width should be 0.40 mm for interior members and 0.32 mm for exterior member. In this study, all the repaired beams as well as control beams showed lesser value of crack width than that of allowable limit for exterior and interior member.

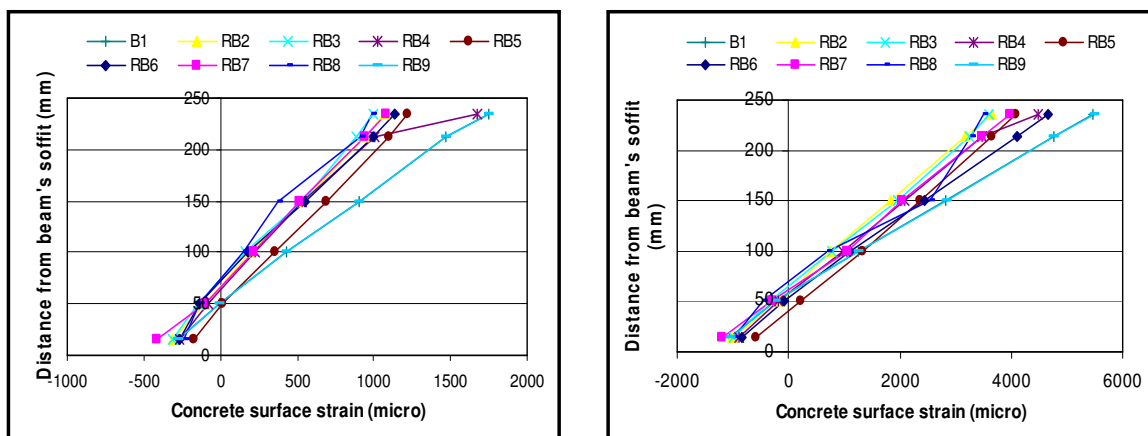
**Figure 9:** a) Location of Neutral Axis at 20 kN Load and b) Location of Neutral Axis at 70 kN Load

During the test, it was observed that the neutral axis of all the beam specimens were shifting up as the load applied increased. The locations of neutral axis for two specified loads are shown in Figures 9(a) and 9(b). These results were compared with theoretical values calculated using the triangular stress method for measuring cracked sections as shown in Table 4.
